HO-1171  
Highlands  
4480 Doncaster Drive  
Private

## Maryland Inventory of Historic Properties Form

Inventory No. HO-1171

historic Highlands

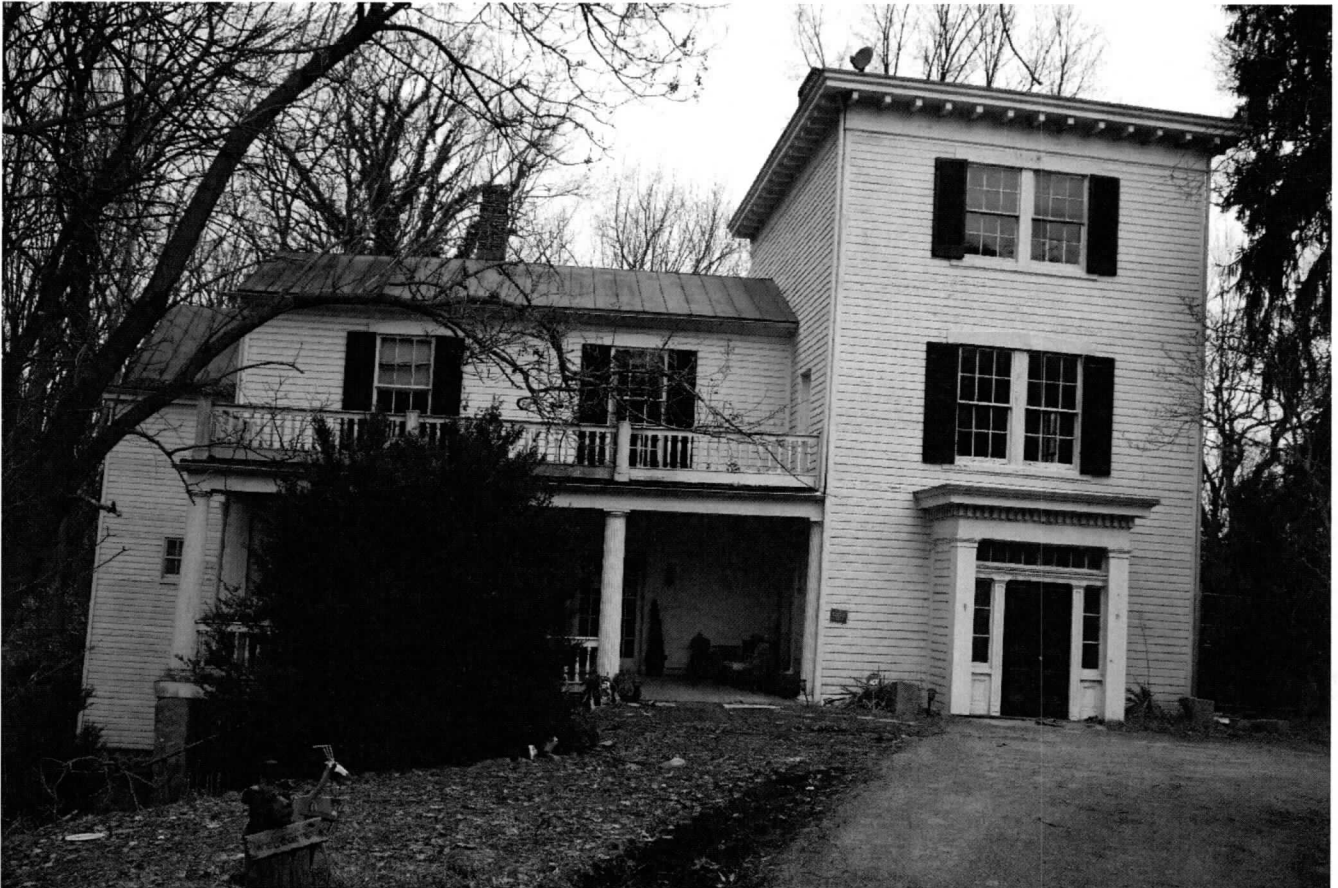
The south elevation of Section 1 has horizontal flush-board siding on the first story and German siding on the second story. The first story has French doors in both bays, of ten lights each, with ghosts in the siding above of pedimented trim and infill siding between the ghosts. The existing pedimented trim around the doors is re-used, with pieces added on both ends because the doors are wider than the original windows. There is a two-bay porch in the re-entrant angle formed by this section and Section 2. It has a wood deck, fluted Doric columns, railings with turned balusters, a plain frieze, and slats on the ceiling. At the west end of the porch, against the siding of the south elevation, is a plain, engaged pilaster with a quirked Greek ogee capital. The shed roof has standing-seam metal and a balustrade that matches the first story, except that the balusters are inverted. The second story has two six-over-six sash with pedimented trim and blinds. There is a wood box cornice with a return on the west. There is an interior brick chimney centered on the ridge between these two bays.

Photo 1 of 22: South elevation. 3/8/2019

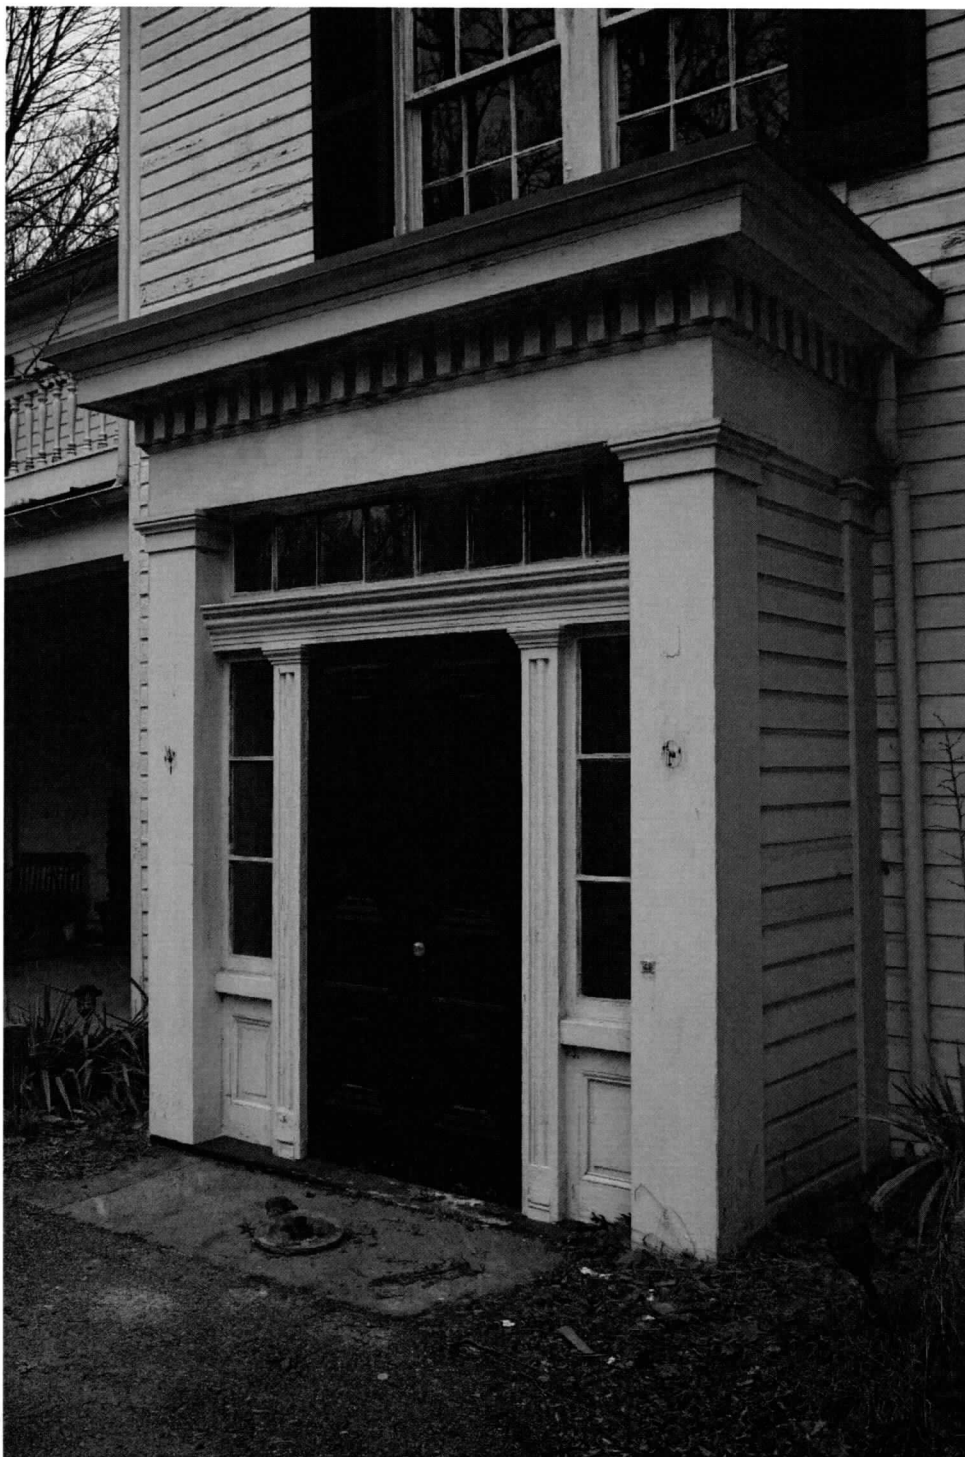
The south elevation of Section 2, on the first story, has a projecting vestibule with a pair of two-panel doors that have sunken double fields and bolection mouldings. There are sidelights with three lights over one panel, with sunken fields and quirked ogee-and-bevel panel moulds. There are pilaster strips between the doors and sidelights that have a symmetrical moulding on the face, with a torus in the center flanked by rabbets to each side. There is a wide transom bar with an astragal at the top, a small fillet, a small ovolo, a torus, another ovolo, and three fillets at the bottom. There is a transom with eight lights. At the corners of the vestibule are plain pilaster strips with quirked Greek ogee caps, a plain frieze with elongated dentils, and an ogee cornice. It has a semi-hip roof of standing-seam metal with internal gutters. The second story has paired six-over-six sash with pedimented trim and blinds and the third story has the same, but the sash are shorter. There is a plain board frieze, a block cornice, and internal gutters, all carried around all four elevations of this section. All four elevations also have German siding, except where noted.

Photo 2 of 22: South elevation, front door. 3/8/2019

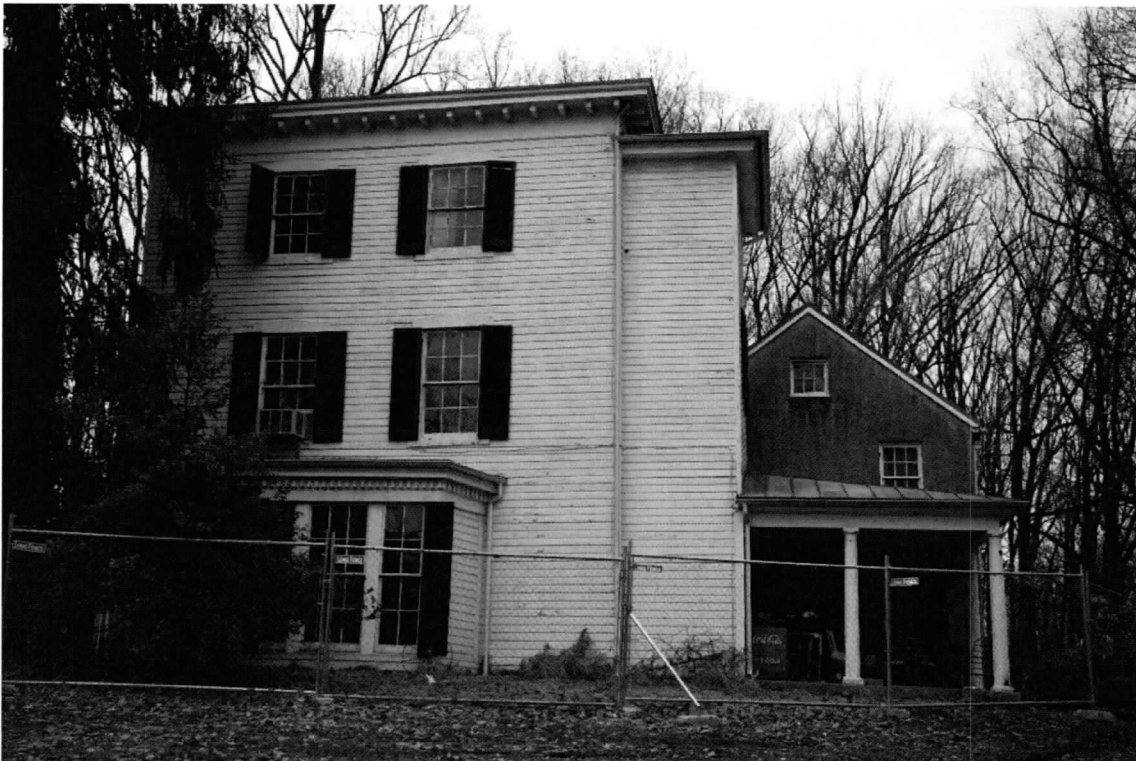
The east elevation of Section 2 has a three-sided bay window on the first story, with a six-over-six sash in the center and a four-over-four sash to each side. The sash extend down to the floor. Above the windows is a plain frieze with elongated dentils and an external gutter. The second story has two six-over-six sash with pedimented trim and blinds, and the third story matches this arrangement, but the sash are shorter.

**Photo 3 of 22: East elevation. 3/8/2019**

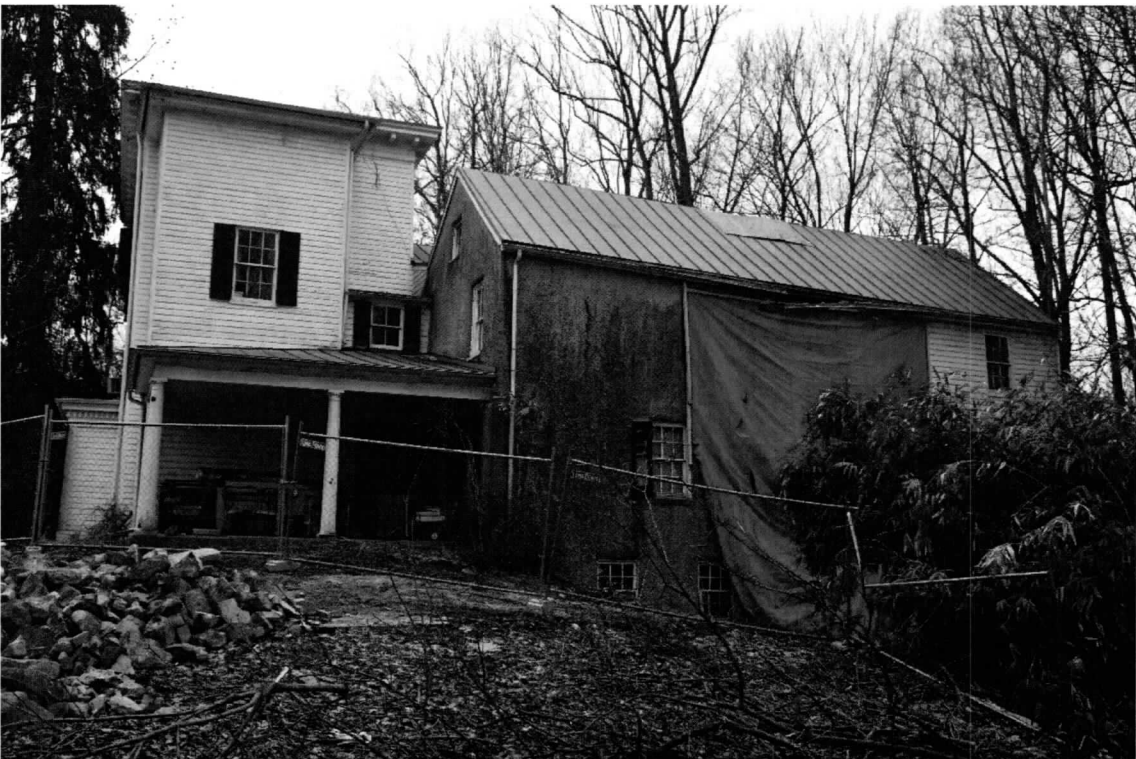
The north elevation of Section 3 has the basement exposed, with a concrete retaining wall several feet north of the building, to the east where the ground level is higher. The basement has two six-over-six sash to the east, the stone wall is missing from the center, and the frame portion has a wood door to the east and a six-over-six sash to the west. The first story, from east to west, has a six-over-six sash centered between the basement openings, the east jamb of a missing window, then the stone wall is missing from the center. The frame portion has a wood door to the east and a six-over-six sash to the west, with a modern deck off of this portion. The second story has a six-over-six sash set west of center, with the stone wall missing to the west of it. The frame portion has a six-over-six sash to the west. There is a wood box cornice.

**Photo 4 of 22: North elevation. 3/8/2019**

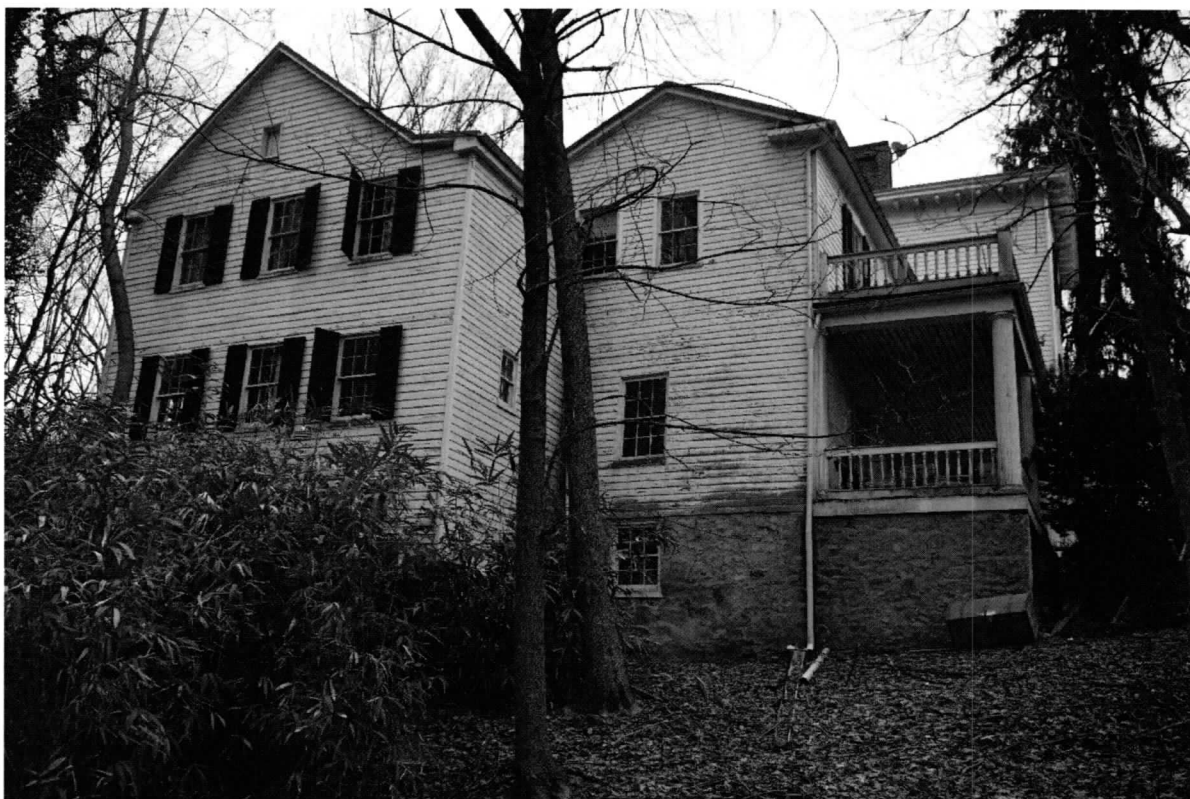
The west elevation of Section 3 projects westward of the west elevation of Section 1 by one bay. The basement, first, and second stories each have three six-over-six sash. There is no opening in the gable end. The south wall laps the west end of Section 1, and the roof pitch on this portion is flatter than the rest of the roof. The south elevation of this projecting portion is one bay, with no opening in the basement or the second story. The first story has a small two-over-two sash, and there is a box cornice with return on the west side.

Photo 5 of 22: West elevation. 3/8/2019

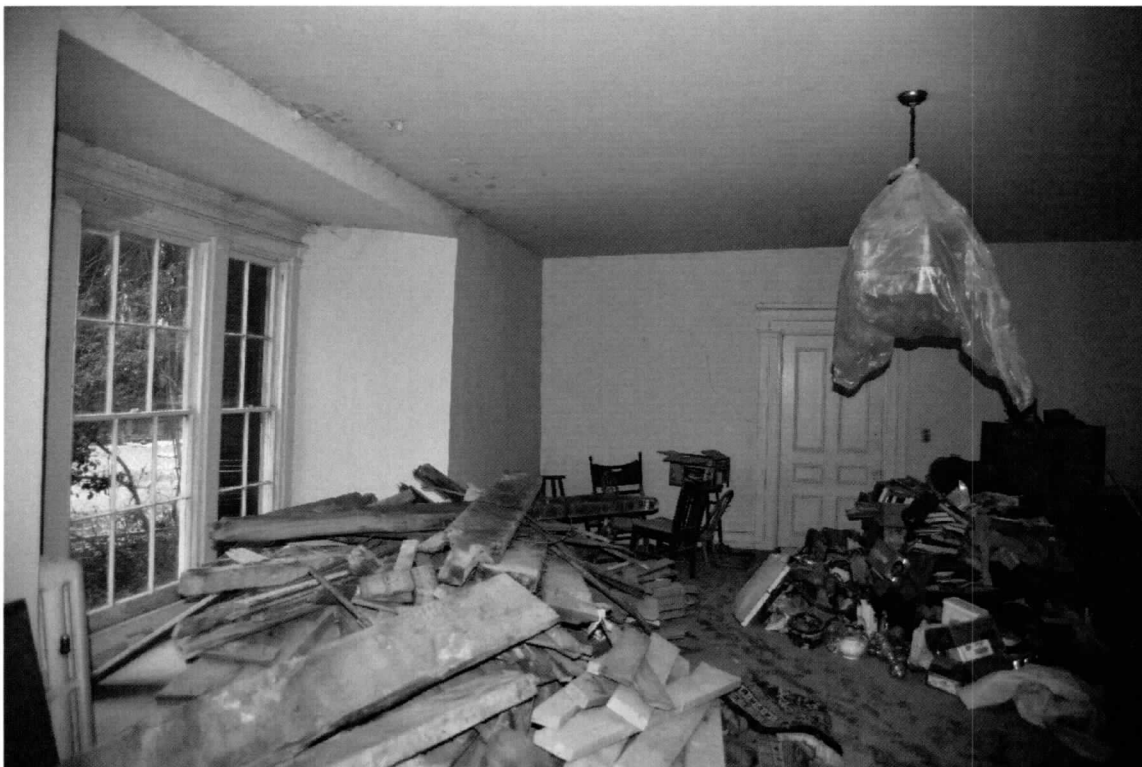
The east room is in Section 2 and the front door opens directly into here from the vestibule. The south door has six panels with the frieze panels in the center, and they have sunken, flat fields with quirked ogee-and-bevel panel moulds. The door is mortised and tenoned and pinned, with one pin in each joint, and it has a mortise lock with porcelain knobs. There are butt hinges with ball finials that replace earlier butts. The architrave on all the doors has pilasters with quirked ogee-and-bevel capitals, a plain frieze, and a cornice with an ovolo above a cavetto. The flooring is random-width, mostly 4  $\frac{3}{4}$  or 5  $\frac{1}{4}$  inches wide, is tongue-and-grooved pine that is blind-nailed, and runs north-south. The baseboard has an ogee on top, except that on the west, between the two doors and around the fireplace, where it has a broken field with a quirked ogee-and-bevel on top. The latter was probably added when the fireplace was re-worked. The fireplace has a brick hearth laid in mortar and a brick surround in Portland cement, with straight jambs. There is a Colonial Revival wood mantel with crossetted architrave, a pulvinated frieze with a panel in the center, and an ogee-and-bevel bed mould. The doors to the north and south of the fireplace, as well as the north door, match the south door. They have brass mortise locks that are not labeled, and the west door, to the north, has glass knobs. All these doors have cast iron butt hinges with five knuckles and probably fast joints. There is heavy paint build-up, but they appear to be plain. The east window sash have 12-inch by 21-inch lights, with Gothic bead muntins. They are mortised and tenoned and pinned at the corners, have check rails and parting beads, and are hung on chains with pulleys. The pilasters, frieze, and cornice match the doors. The jambs of this bay window are curved and plastered.

Photo 6 of 22: Southeast room, view southeast. 3/8/2019

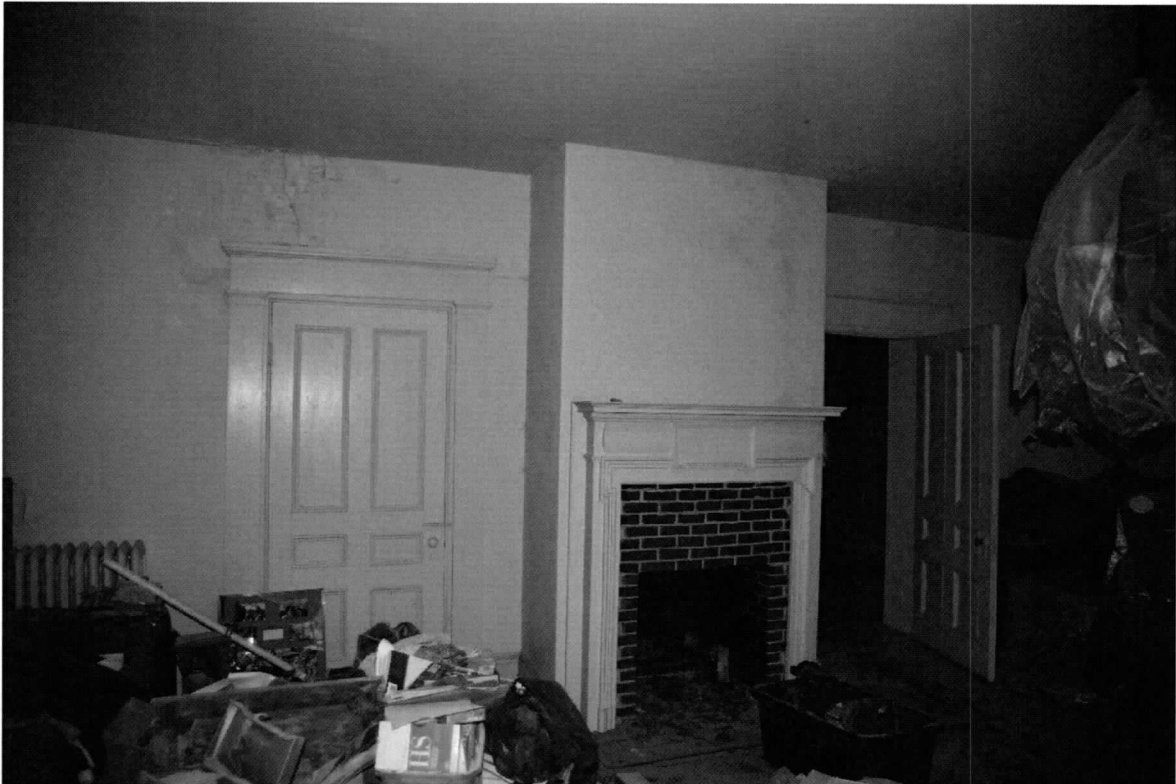
**Photo 7 of 22: Southeast room, view northwest. 3/8/2019**

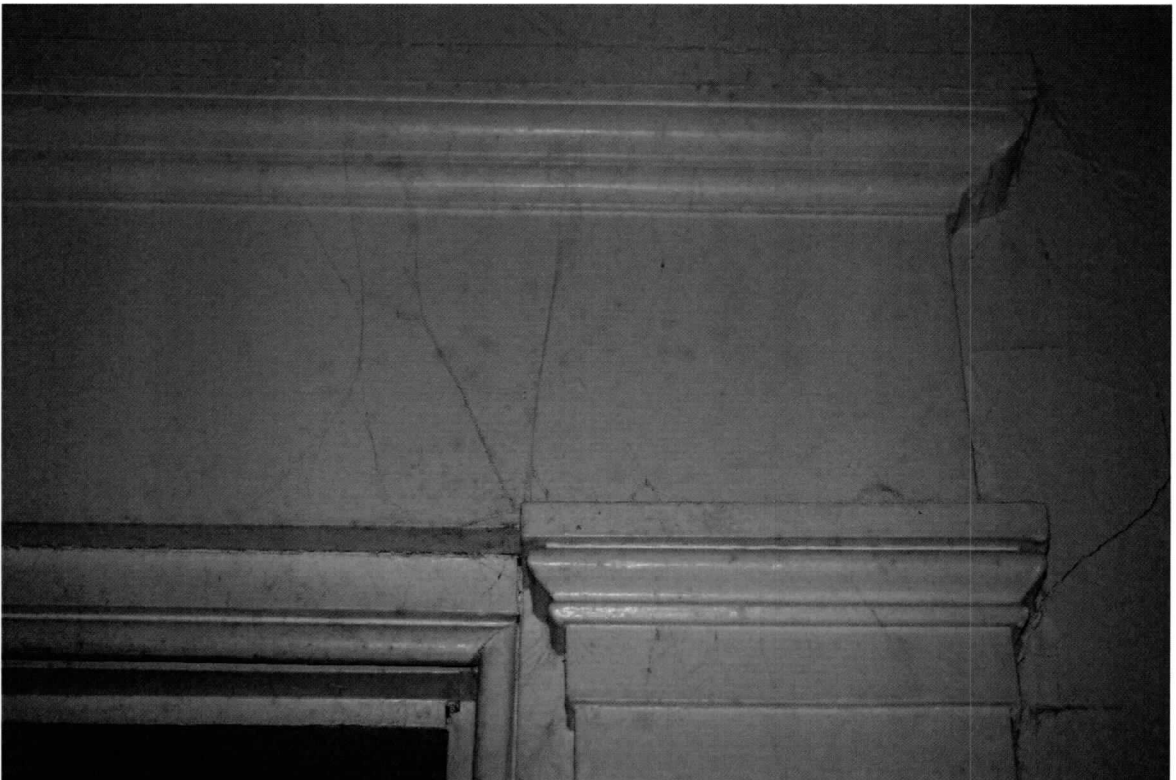
**Photo 8 of 22: Southeast room, architrave detail. 3/8/2019**

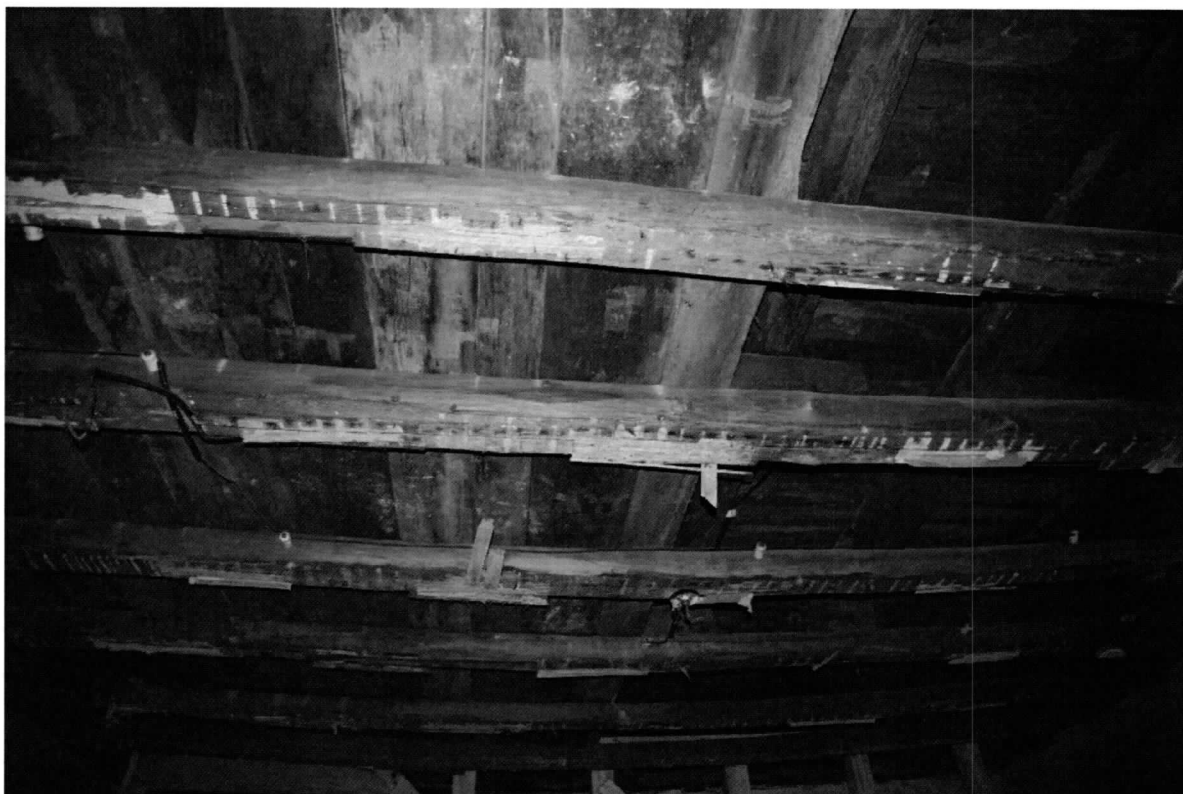
The lath and plaster ceiling in this room was taken down, exposing log joists that are hewn on top and bottom, and they run east-west. They contain some riven lath that is nailed parallel to the joists and was apparently used as shims. There are also several pieces of sawn lath running perpendicular to the joists. The northern-most joist retains some riven lath that is nailed perpendicular to the joist. The joists are about 4 inches deep and about 6 ½ inches in diameter, and are spaced 21 ½ to 28 inches on centers. The ceiling is 9 feet, 10 inches high. At the west wall are the ends of log joists for the southwest room, set next to these joists. The western half of these joists have tongue-and-grooved, random-width flooring that varies between 4 ¾ and 11 inches wide, with most boards around 7 inches. The eastern edge of the eastern-most floorboard does not have a tongue or a groove and appears to be cut, not broken. There is a second set of joists above these, and they run north-south. They are circular-sawn, are 3 inches deep by 8 inches wide. The upper tier joists are cut back on the bottom face about 1 inch and sit on sawn girts on both the north and south ends. There are blocks under each of the upper joists where it crosses the fourth lower joist from each end. At least four of these blocks are the cut-off ends of what were probably joists, with center tenons on the end that are 3 inches long. The tenons were not pegged. At the west end of the ceiling, in the center of the west wall, is the hearth support for the fireplace above. The header is sawn and is 2 inches wide; its depth could not be determined. It appears to be lapped to sit half on top of the lower tier of joists, suggesting that it was added in. There are three iron straps set into the brick chimney stack on the west end and curved up on the east where they are fastened to the trimmer. There is a single board set on the straps, but they do not support anything else. Above this are short boards that run from the stack to over top of the trimmer, and they likely support the brick hearth.

**Photo 9 of 22: South-center room ceiling framing, view north. 5/9/2019**

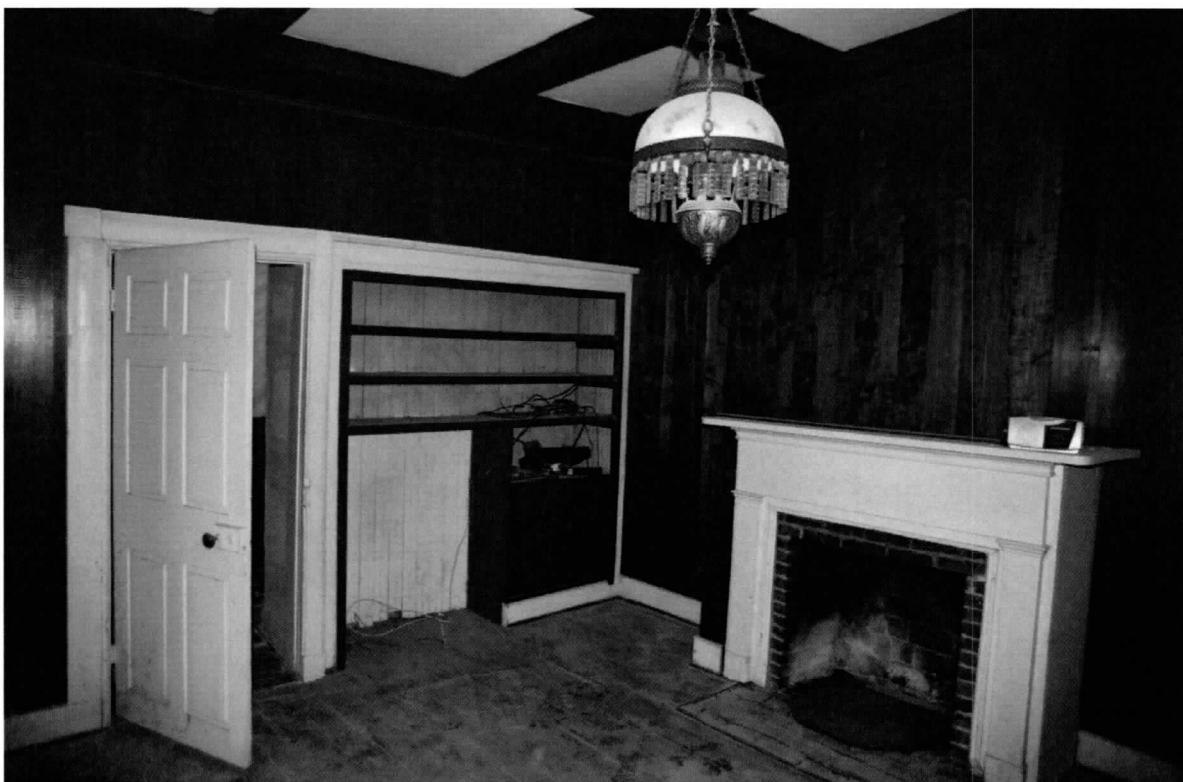
The southwest room in Section 1 has random-width tongue-and-grooved pine flooring that runs north-south and is face-nailed. The boards vary between 4 ½ inches and 6 inches wide. The walls have been furred out and vertical boards with a natural finish nailed on. The south French doors match those in the south-center room, as does the trim. The east door architrave matches that on the south-center room side of this opening. The west window is a six-over-six sash with ovolo muntins and 10-inch by 13-inch lights. It is mortised and tenoned and pinned at the corners and has no parting beads. The trim is plain, with a narrow fillet across the whole bottom edge of the top piece. There is a fireplace on the east wall, with a brick hearth and splayed brick jambs in Portland cement. The back of the firebox has fire bricks set rowlock. There is a wood mantel with pilasters that have quirked ogee-and-bevel capitals. It has a plain frieze, an ogee-and-bead bed mould, and a plain shelf that continues around the south side of the stack. There is a doorway in the north wall with a six-panel door that is mortised and tenoned and pinned, with two pins in the lock rail joints and one in all the other joints. It has sunken fields and no panel moulds. The lock rail appears to be hand-planed, with the marks being faint. There is a plain cast iron rim lock with beveled sides and brass knobs, and it appears to be the original lock on this door. The cast iron butt hinges have five knuckles and appear to be plain, with fast joints, but have thick paint. The architrave is pulvinated, with plain corner blocks. To the east of the doorway the wall is recessed and infilled with later shelves. The back and side walls of the recess are beaded-edge-and-center vertical boards, and this appears to have been a cupboard or closet that was altered when the walls, ceiling, and fireplace were renovated. The ceiling has wood beams added, creating nine large coffers in the center with small square coffers in the corner and three small rectangular coffers on each side. The beams are boxed, varnished pine with quarter round mouldings on the bottom corners. The ceiling between the beams is plaster.

**Photo 10 of 22: Southwest room, view northeast. 3/8/2019**

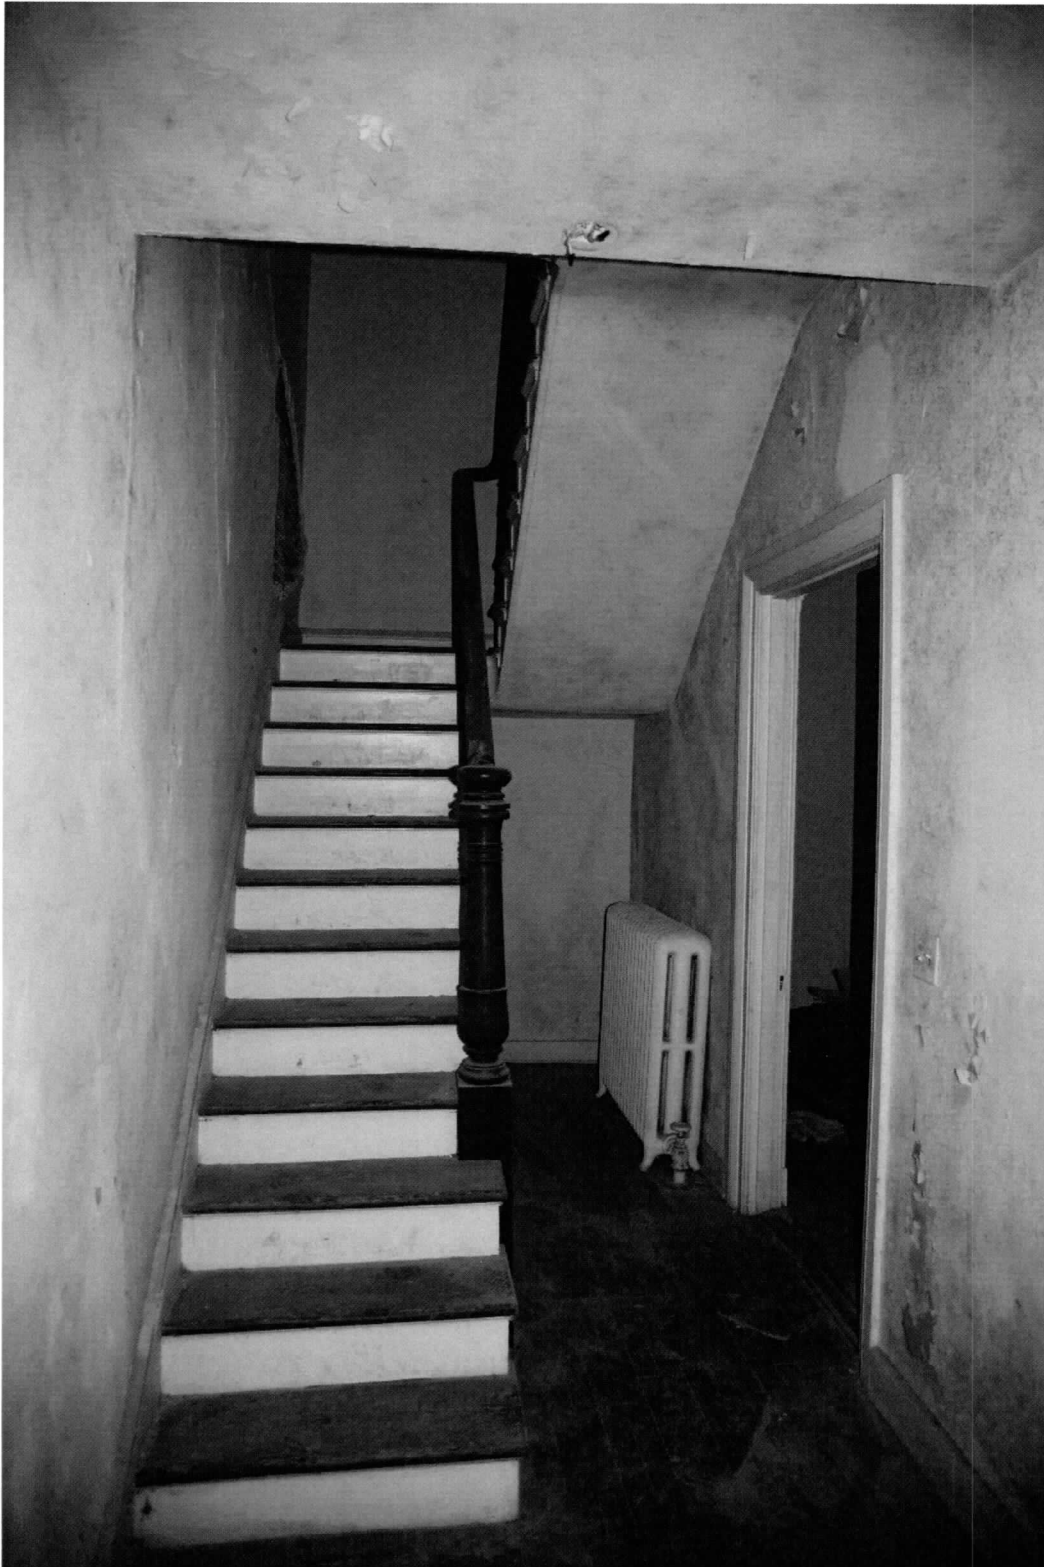
The stair passage is located in Section 4, at the north end of Section 2. The flooring is 2 ½-inch wide tongue-and-grooved pine that runs east-west. The baseboard is plain except on the north wall, at the stairs, where it has a Greek ovolo on top. Under the stairs the original flooring survives. The architrave has a quirked Greek ovolo backband and a quirked bead on the inner edge. The west elevation doorway has plastered stone jambs and a frame that is mitered at the corners and has a quirked bead on the inner edge. There is a four-panel door with sunken fields and ogee panel moulds. It is not mortised and tenoned and pinned, is hung on butts with pins, and has a brass mortise lock with brass knobs. The north elevation has a doorway set to the west, leading to the north porch. It is mortised and tenoned and

Photo 11 of 22: First story stair passage, view east. 5/9/2019

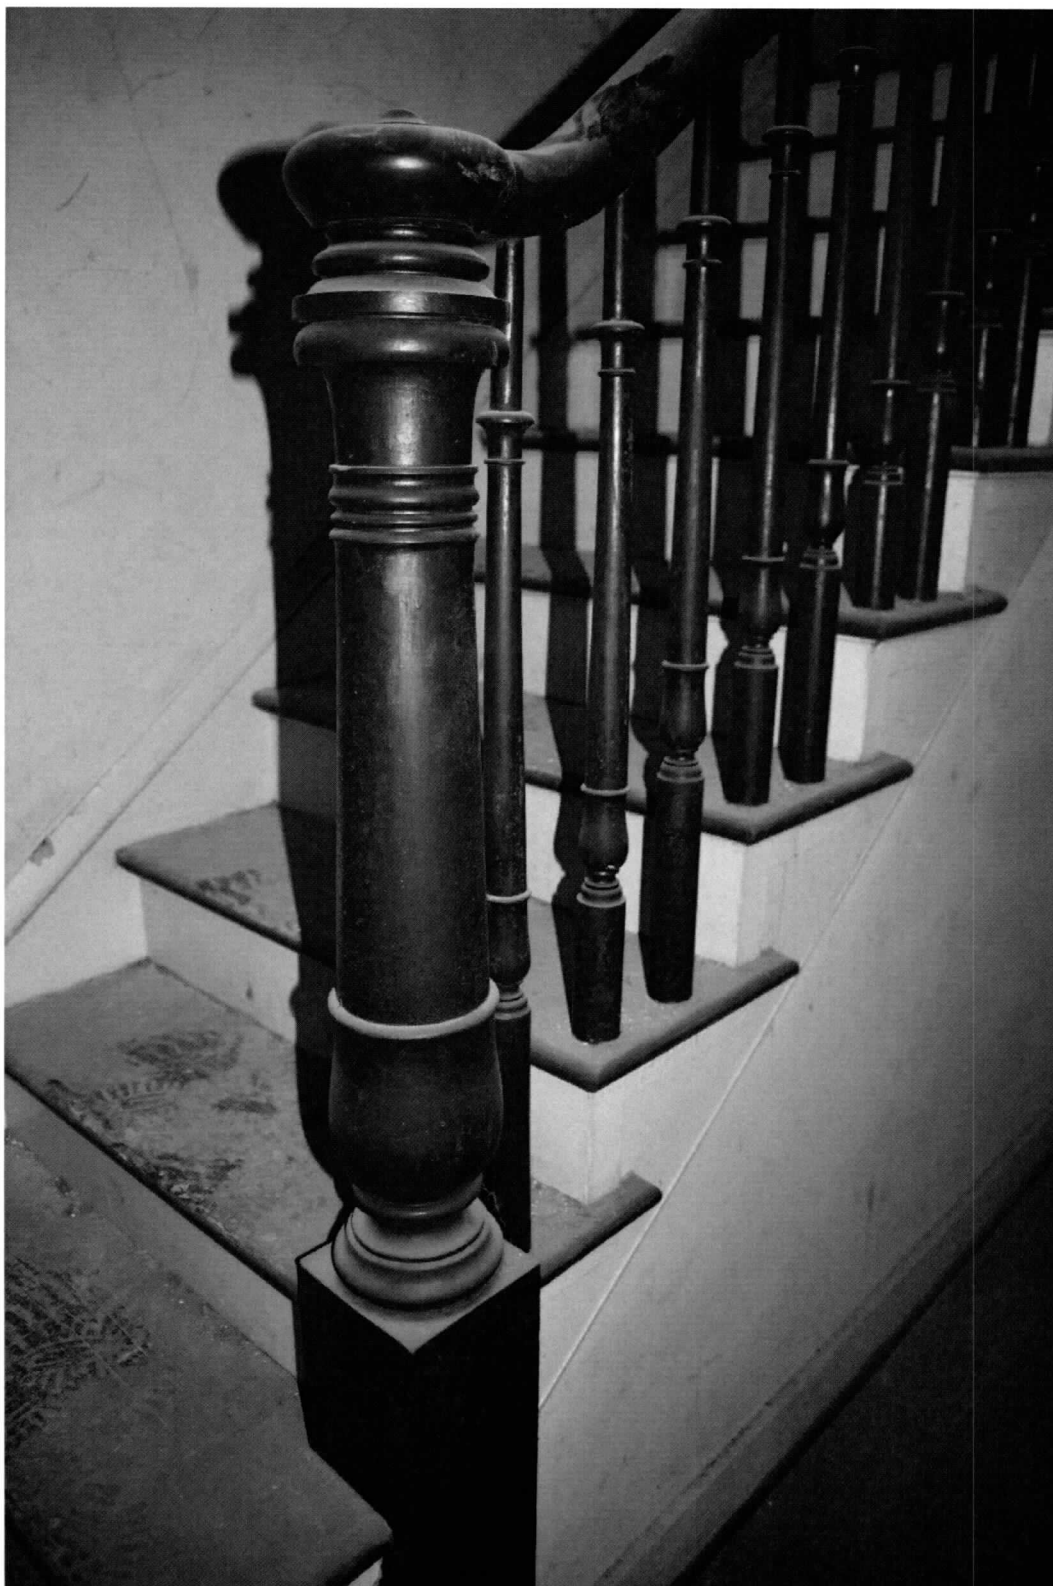
**Photo 12 of 22: First story stair passage, newel. 3/8/2019**

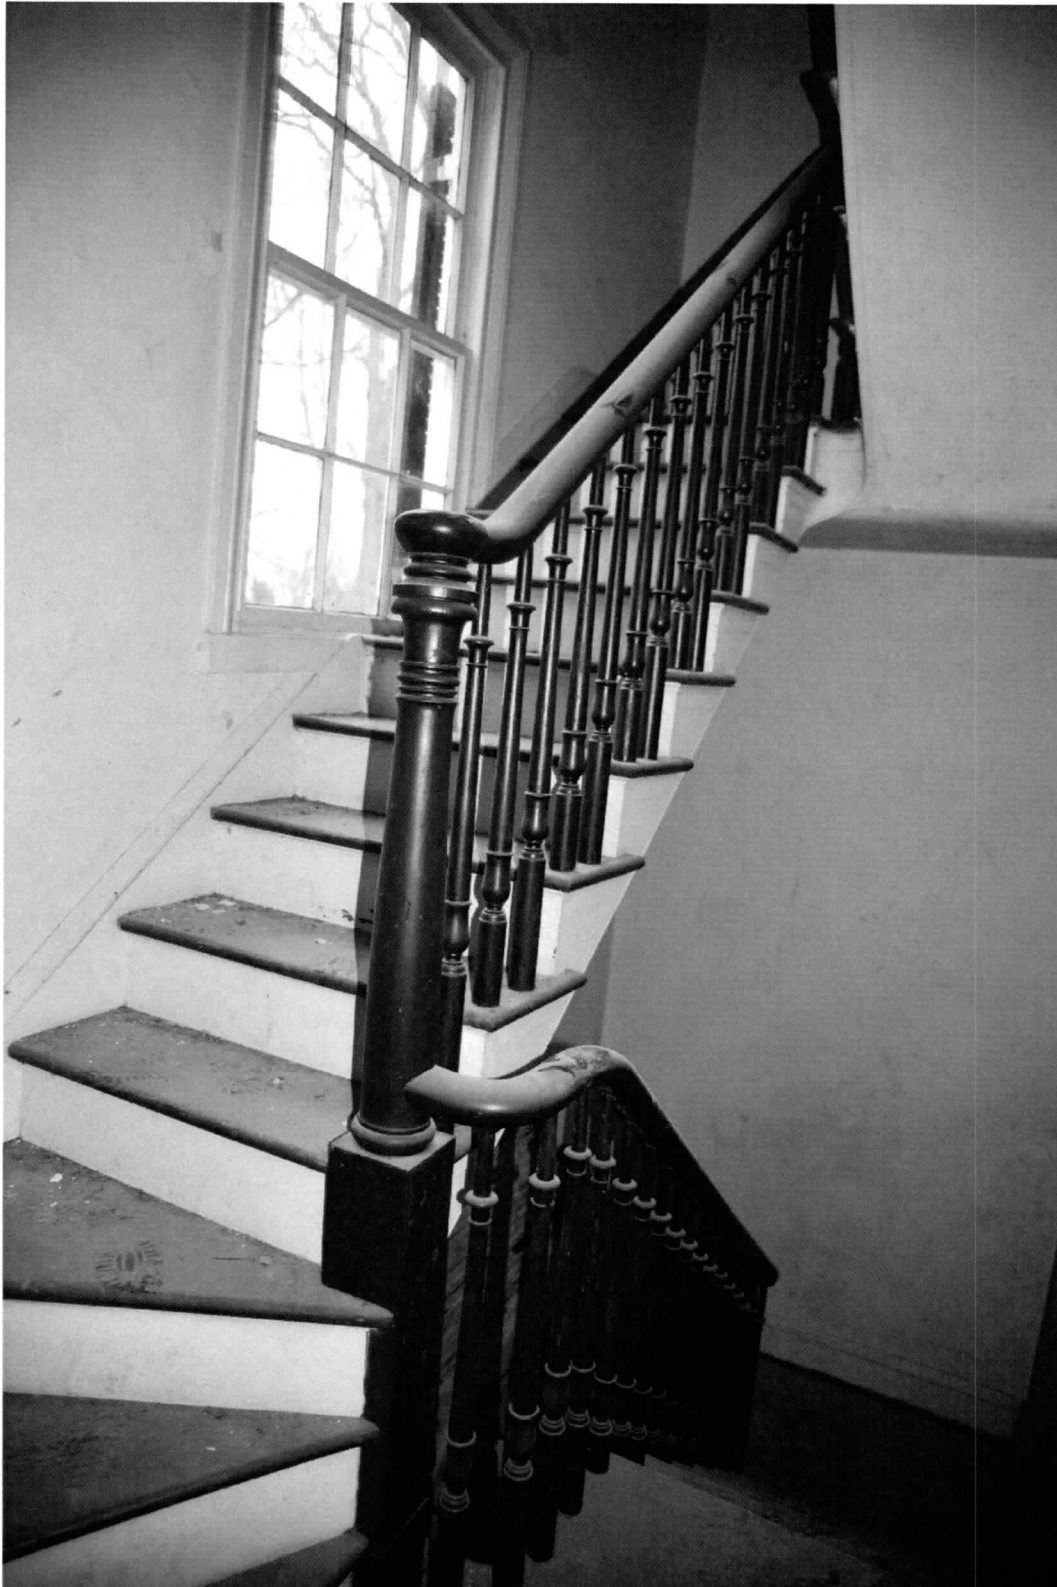
The stair passage in Section 4 has plaster missing from the north wall at the landing. The lath is circular-sawn, with cut nails. The north girt is sawn, is 4 inches thick by 8 inches high, and has been nicked to take plaster. The studs are sash-sawn, are 3 ¼ inches deep by 3 inches wide, and are mortised and tenoned and pegged to the girt with ¾-inch diameter pegs. The pegs are alternately driven from the south side, and then from the north side. There is a downbrace from the corner that is a sash-sawn 1-inch by 8-inch board, set in the outer plane of the wall. It has wire nails coming through it, probably from the German siding. The stair continues up to the third story with the same details, and has a winder at the bottom of the section up to the third story. There is a doorway on the west, and the cross-passage continues to the west through the center of the house, in Section 3. There was never a door here, but there is architrave with a cavetto inside of the outer backband, and a bevel on the inner edge. There is

**Photo 13 of 22: Second story stair passage, view northeast. 3/8/2019**

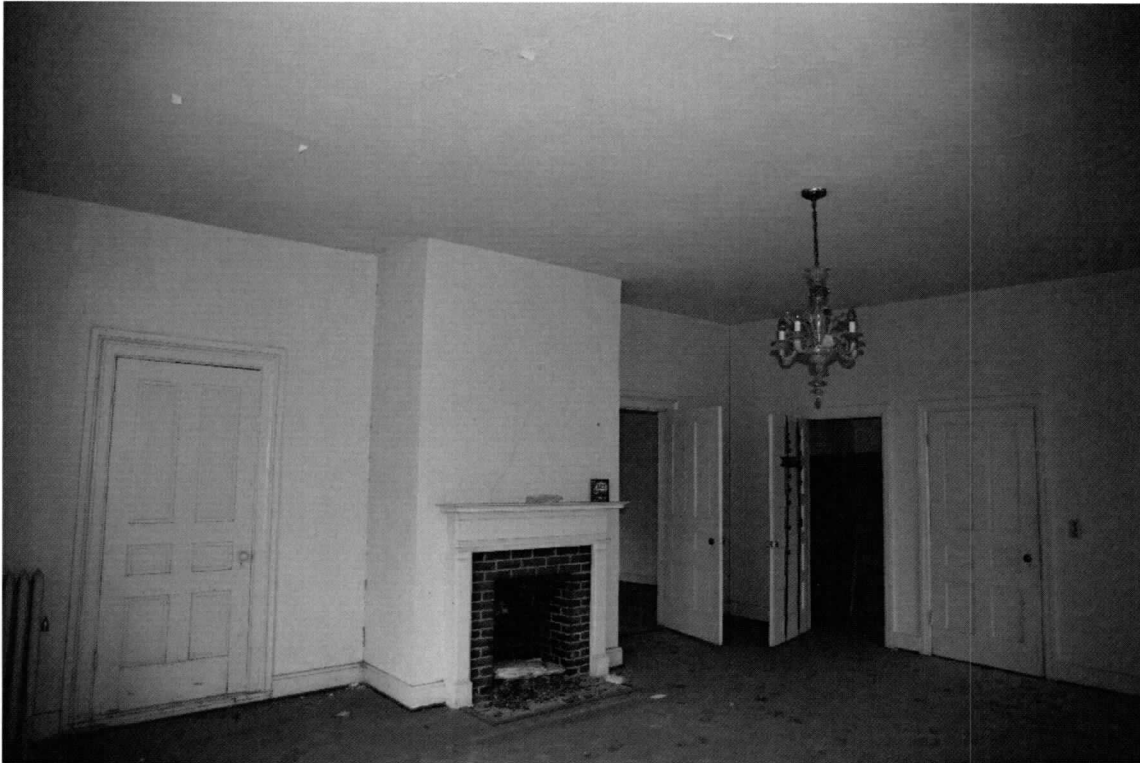
The southeast chamber is in Section 2. The flooring is tongue-and-grooved pine that varies between 3  $\frac{3}{4}$  inches and 5  $\frac{1}{4}$  inches wide, runs north-south, and is blind-nailed. The baseboard has a broken field. The architrave has a quirked ogee-and-bevel backband, and the inner stop on the windows is flush with the architrave and is rounded on the front edge, creating the appearance of a bead on the inner edge. The north wall has closets built in on both sides of the doorway, creating a vestibule between them. The

**Photo 14 of 22: Second-story southeast chamber, view northwest. 3/8/2019**

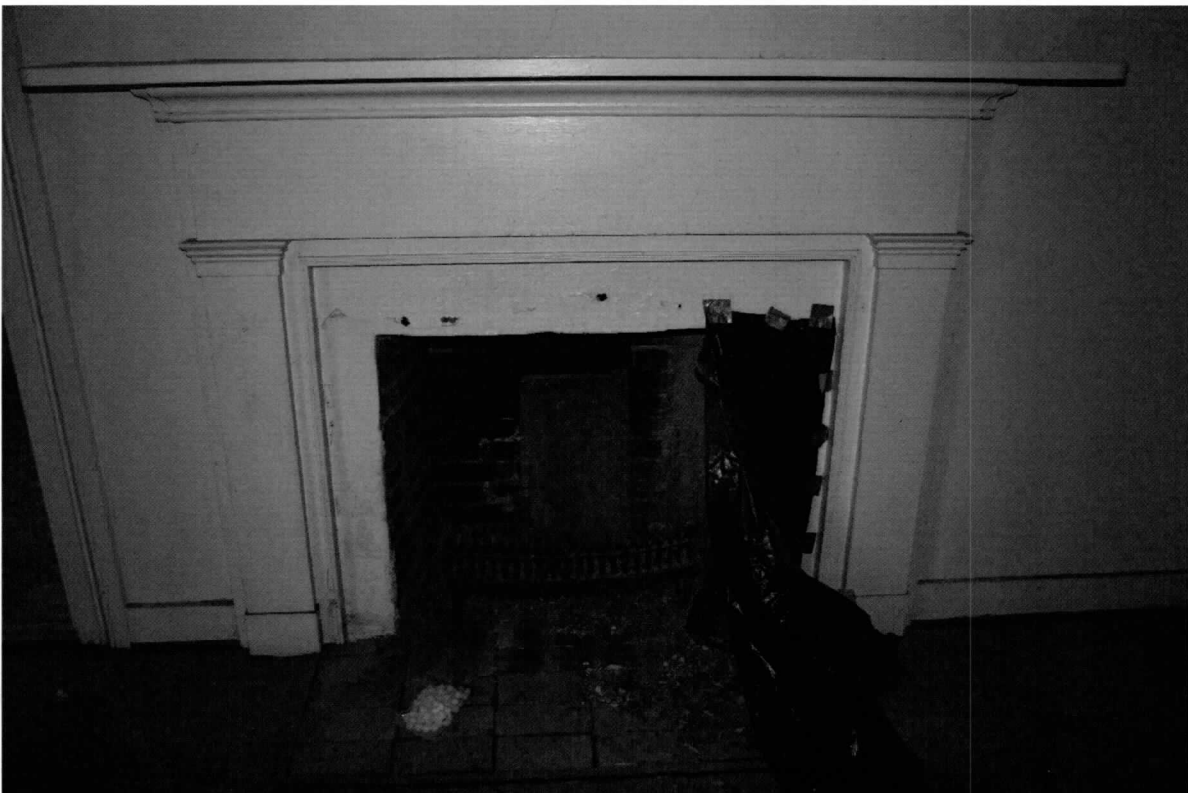
**Photo 15 of 22: Second-story south-center chamber, mantel. 3/15/2019**

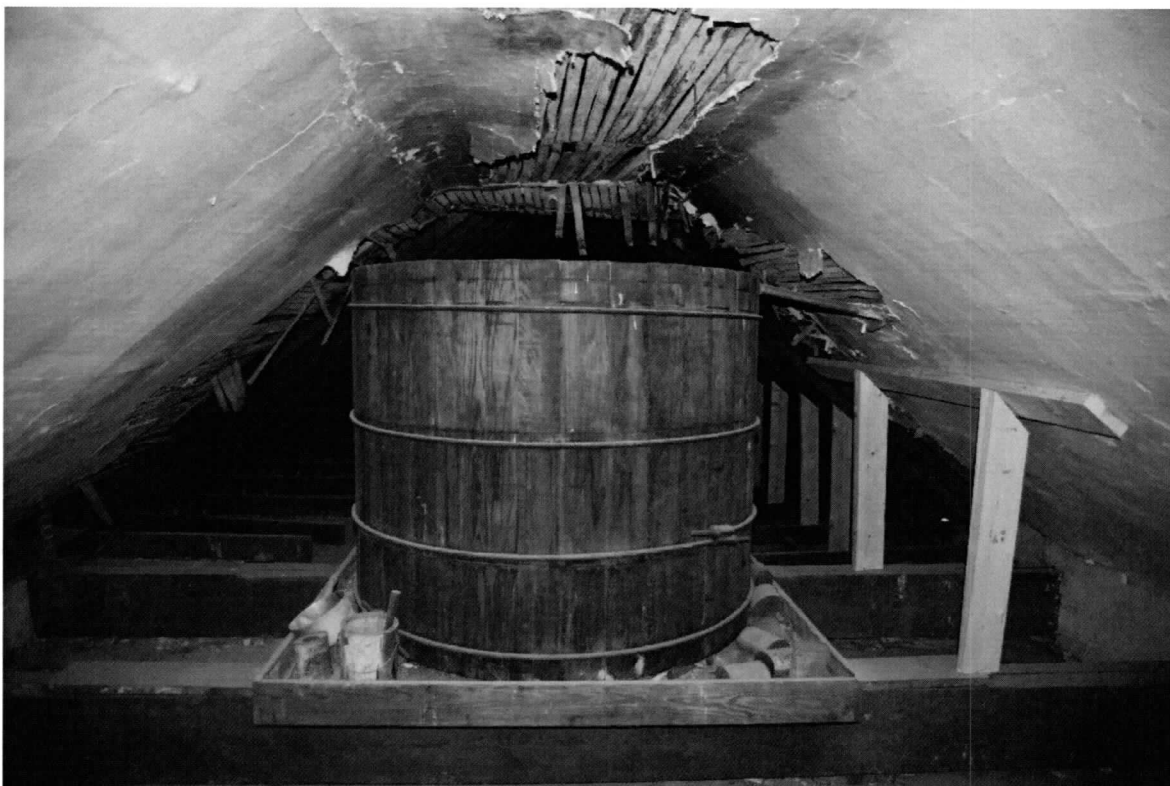
**Photo 18 of 22: Cistern in attic of stone section. 3/8/2019**

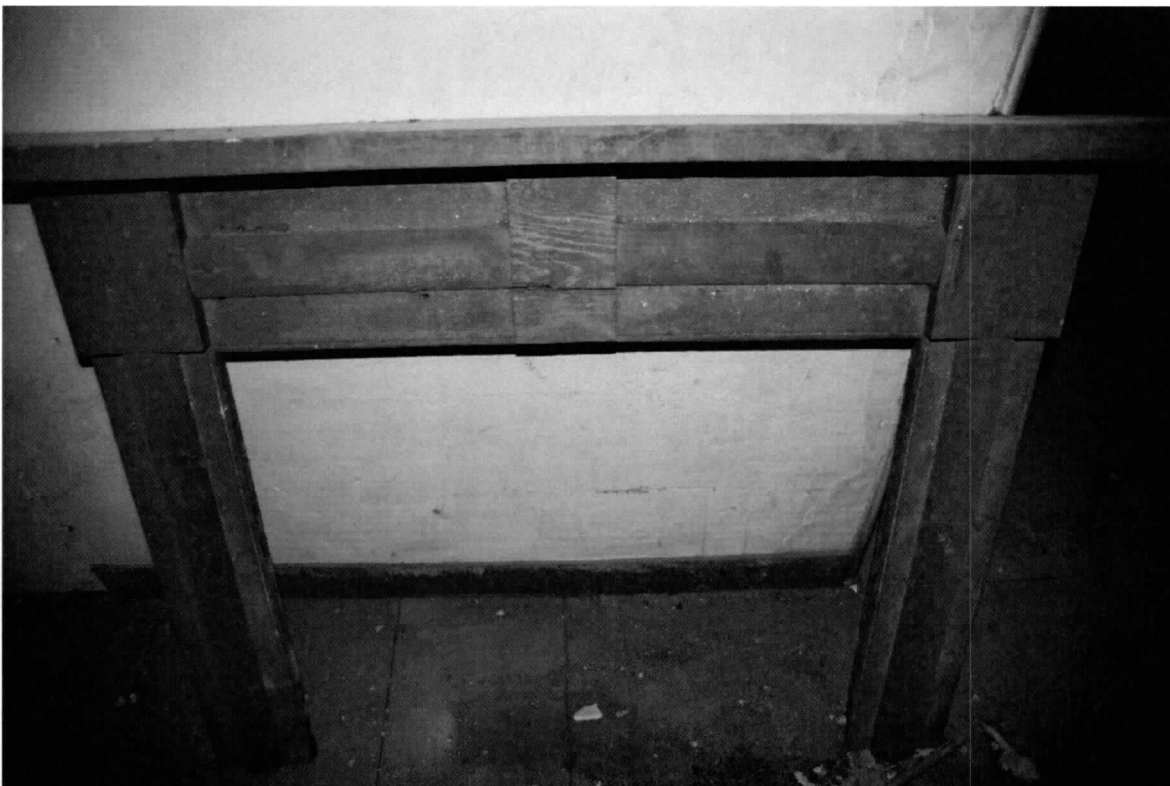
**Photo 19 of 22: Mantel stored in attic of stone section. 3/26/2019**
