HO-1171  
Highlands  
4480 Doncaster Drive  
Private

## Maryland Inventory of Historic Properties Form

Inventory No. HO-1171

historic Highlands

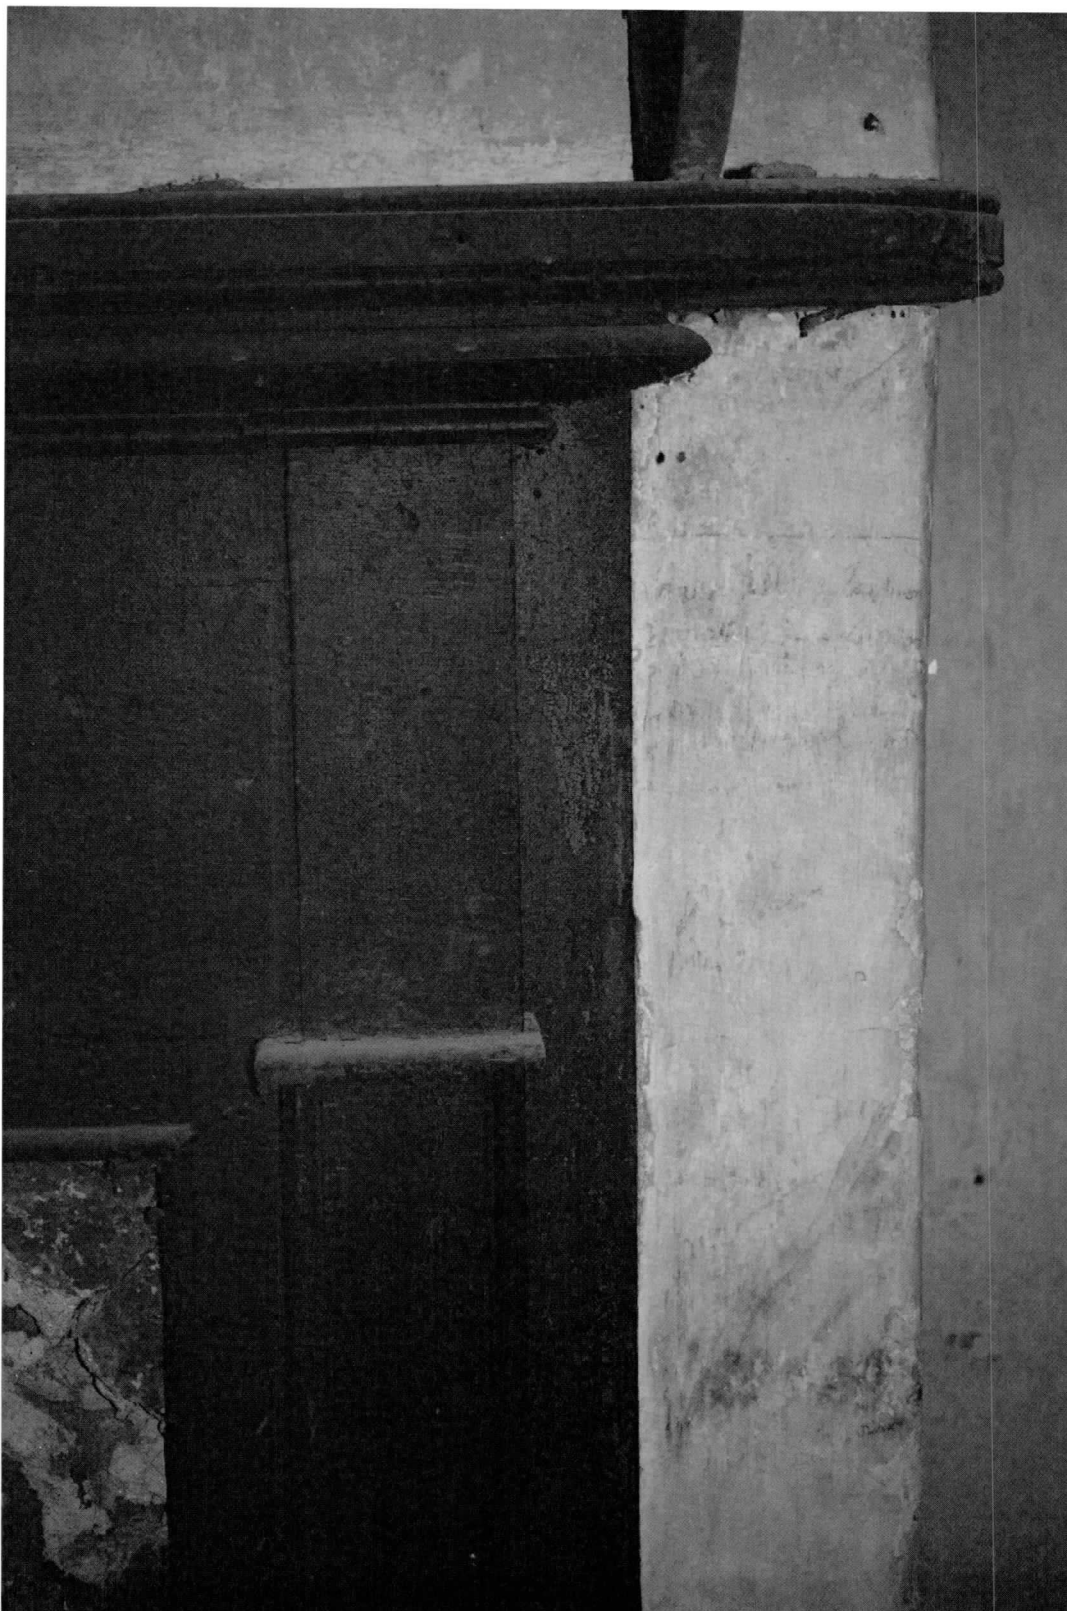
Photo 20 of 22: Basement, southwest room, mantel detail. 3/26/2019
